# HEMPSHILL HALL

## Nuthall

This is a short account of the history and restoration of Hempshill Hall, significant parts of which were built in 1497, only twelve years after Richard III was killed at the Battle of Bosworth Field.

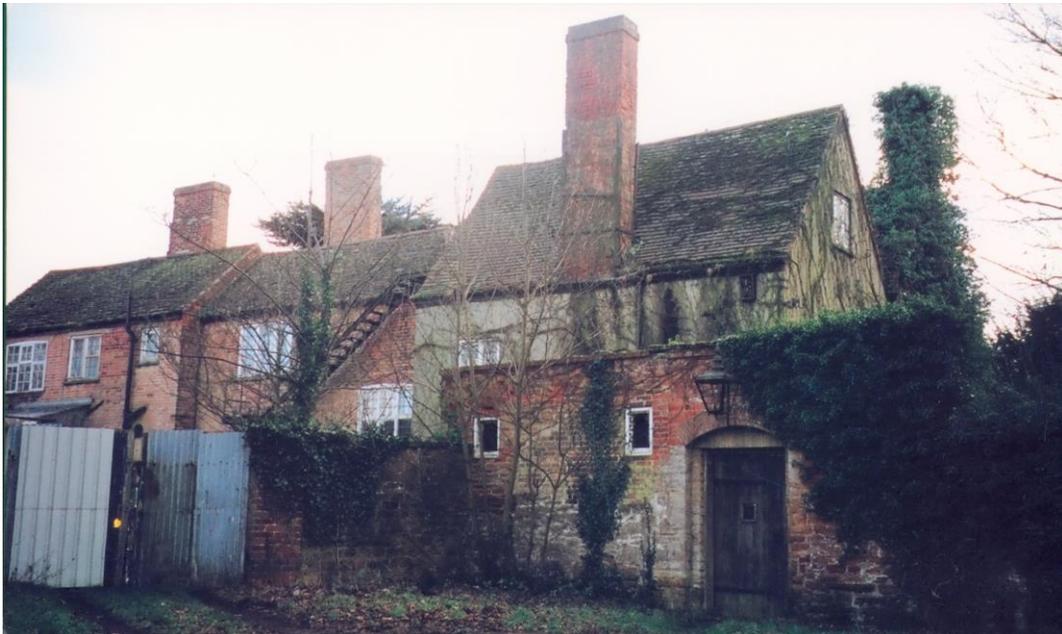
The North Front (winter)

As can be seen from the various pictures, the majority of the windows were broken and there were other holes in various places so temporary glazing and plastic sheets were put in place to keep the weather out and make the house look slightly less abandoned whilst plans were drawn up and listed building consent for the major repair works sought. As the Hall's listing, (apparently on account of an earlier Arts and Crafts Revival makeover), was Grade 2, approval was only required from the local council and their conservation officer Jason Morden of Nottinghamshire County Council, who, as the works progressed and more evidence of the Hall's history was revealed, did suggest that the building deserved upgrading. However, this would have been a mixed blessing as had it been listed 2\* the process would have become more complex, taken longer and been even more expensive as at 2\* every piece of work requires approval by English Heritage instead of just the local council.

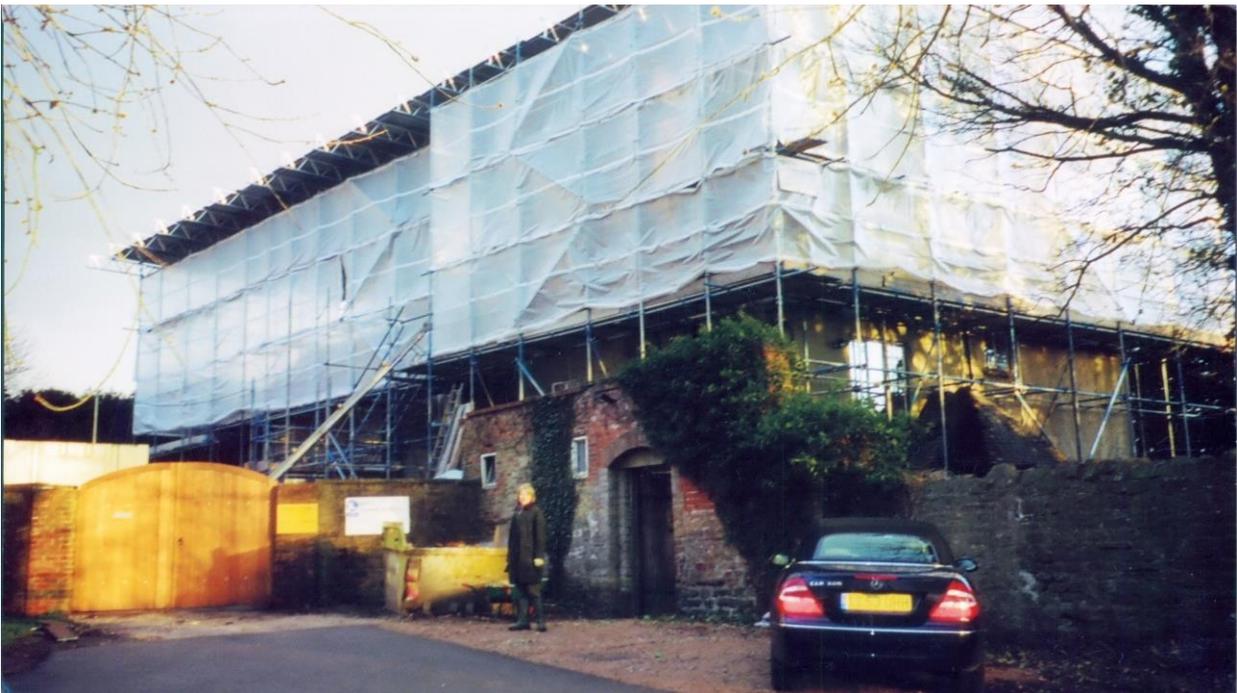
However, whilst the five hundred year old roof beams proved to be in excellent condition the same could not be said of the roof covering itself. It had always been clear that the tiles on the front half of the roof were showing more than usual signs of wear and tear and would have to be replaced, but it had been hoped to remove, clean and reuse those at the rear. Unfortunately closer inspection showed that these had at some stage been cemented together, which meant that the entire roof had to be stripped and 25,000 new tiles, (half of them hand-made), had to be bought and fixed. This was clearly going to take some time and in order to allow work to continue in all weathers and also to make access to the chimneys somewhat easier it was decided to enclose the entire building with what to all intents and purposes was a scaffold hat.

Somewhat surprisingly the inspection of the chimneys revealed that the chimney which was supported by a steel framework was structurally sound , (it appeared that the chimney was actually supporting the steel and not the other way round), but to compensate for this good news another of the chimneys proved to have a complete row of bricks missing along one side at the point where it met the roof. This gap had been carefully filled with paper, given a coat of plaster and a bit of paint and had somehow managed not to fall through into the drawing room. But in the end three of the seven chimneys had to be taken down and completely rebuilt.

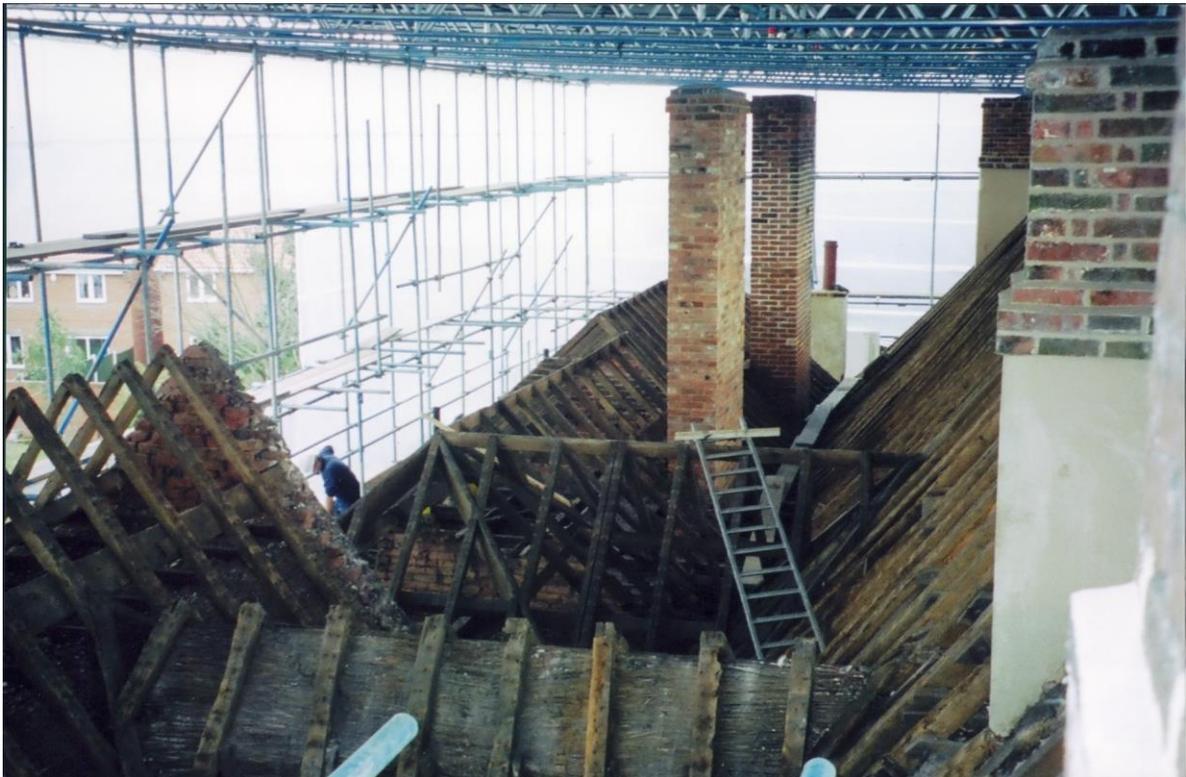
View from the West with the tiles removed and showing 5 of the 7 chimneys

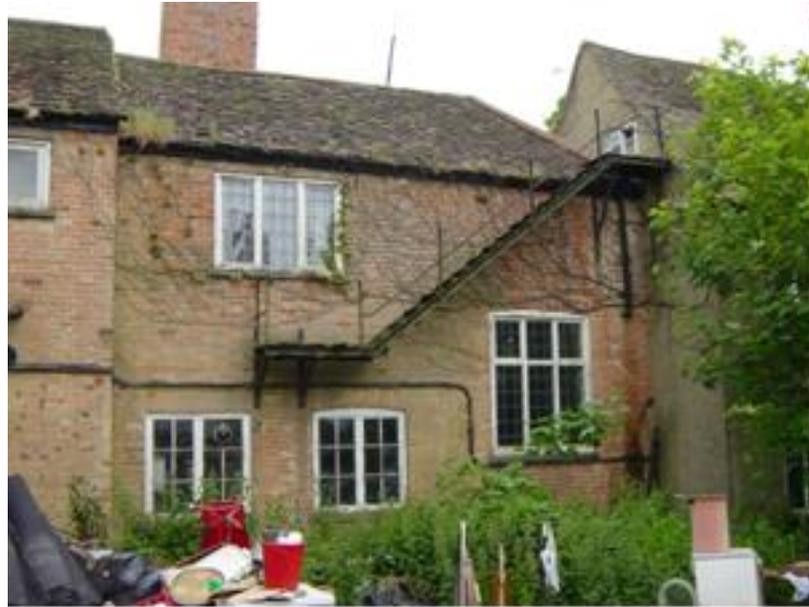
Part of the North face of the Hall from the courtyard, (Spring) – note the termination of the fire-escape!

Meanwhile on the north face of the house, the fire-escape, (which came to an abrupt end half-way to the ground), was removed and the garage, (basically a collapsing flat-roofed plywood shed with vegetation growing 6' high on top of it), was taken down and in time replaced by something more in keeping with this aspect of the house, and attention was turned to the drains and sewers.

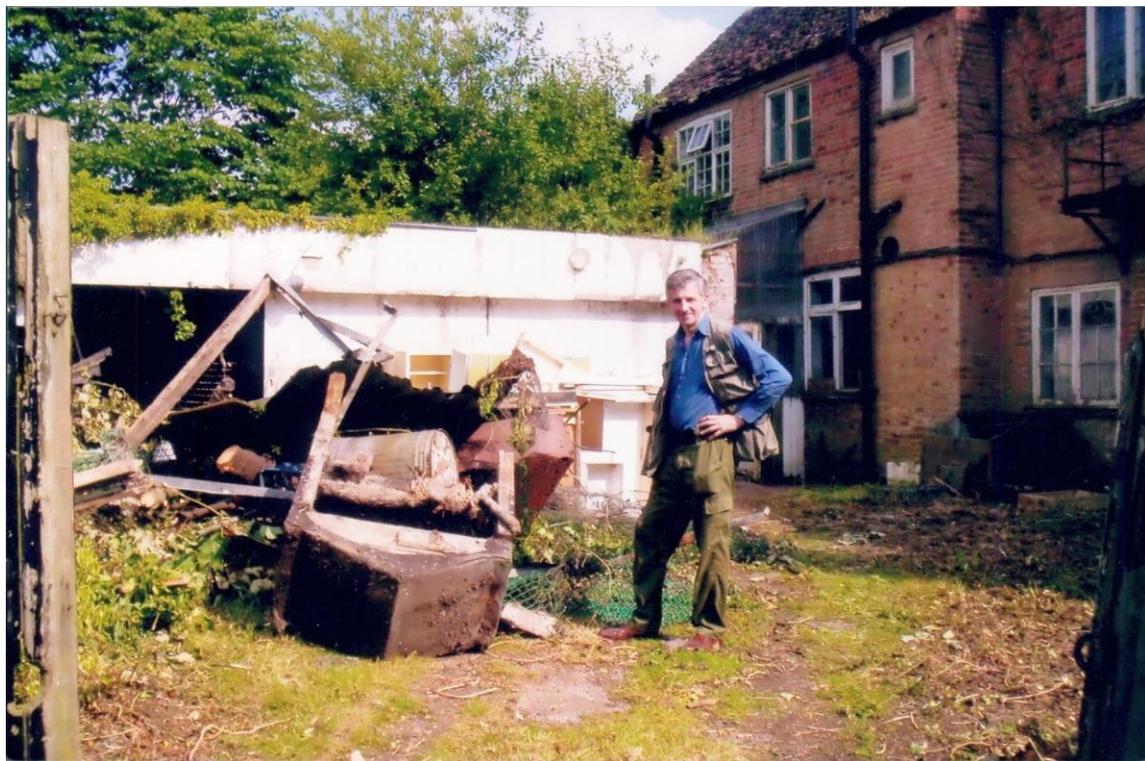
The Garage with “roof garden” and remains of some of the animal cages.

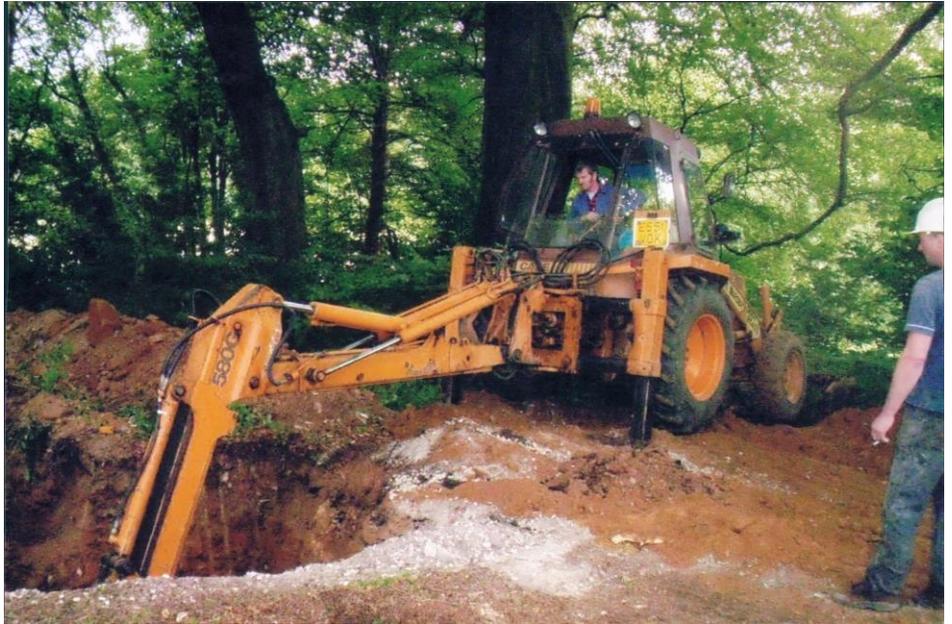
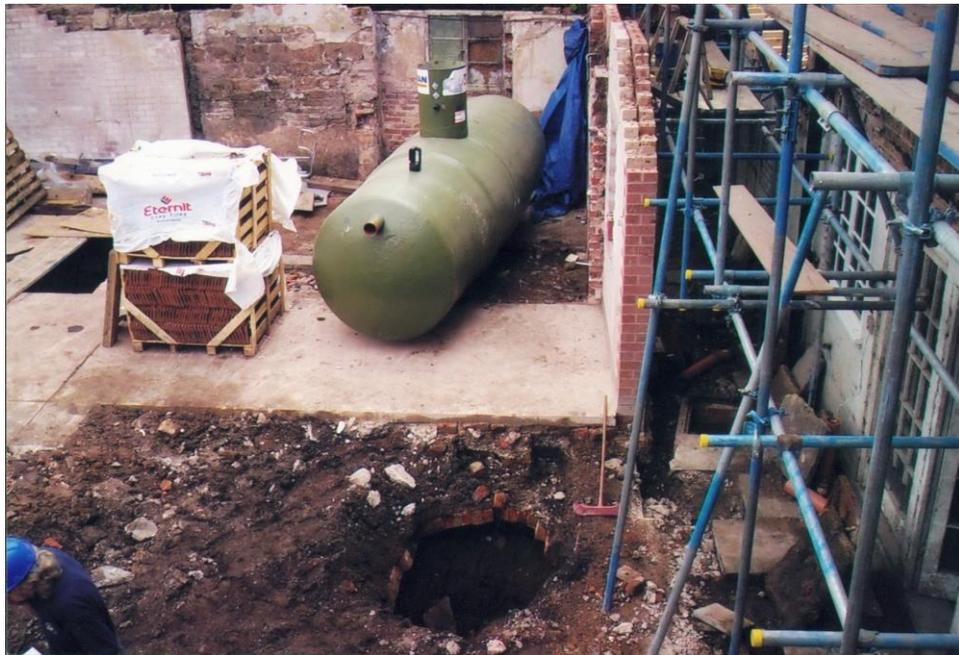
Brick Water Cistern found  
outside Kitchen Door  
(With Foreman Jed Morris  
and Architect Peter Rogan)

- A large brick built water cistern, (19<sup>th</sup> century?), was found in the courtyard just outside the present kitchen door.

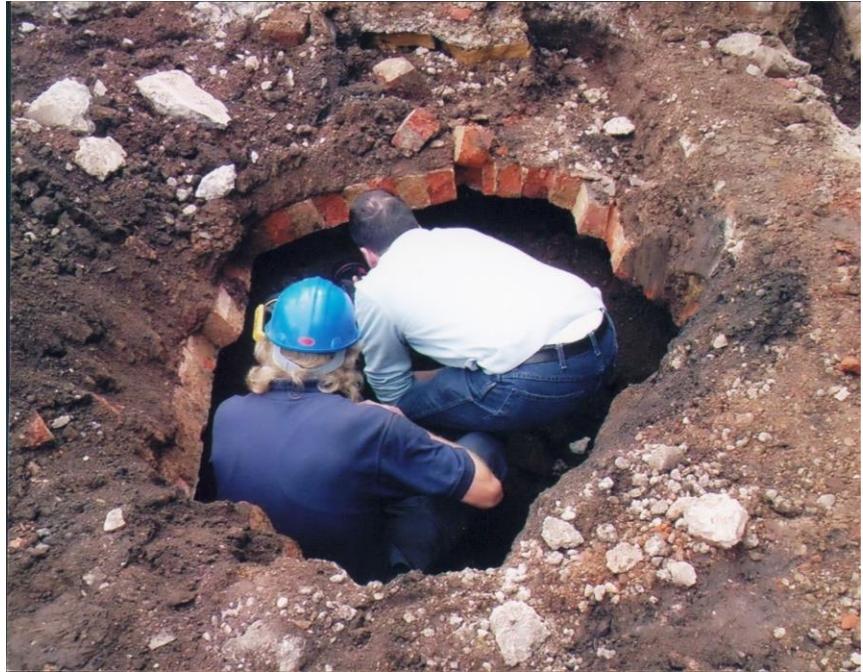
At the same time, a grey-water storage tank the size of a small submarine was installed under the courtyard in order to enable rainwater collected from the roofs of the house to be used for the toilets, the washing machine and for watering the garden. This, co-incidentally, was positioned close to an apparently Victorian brick built cistern discovered just outside of the kitchen door whilst putting in the foundations for the new garage.

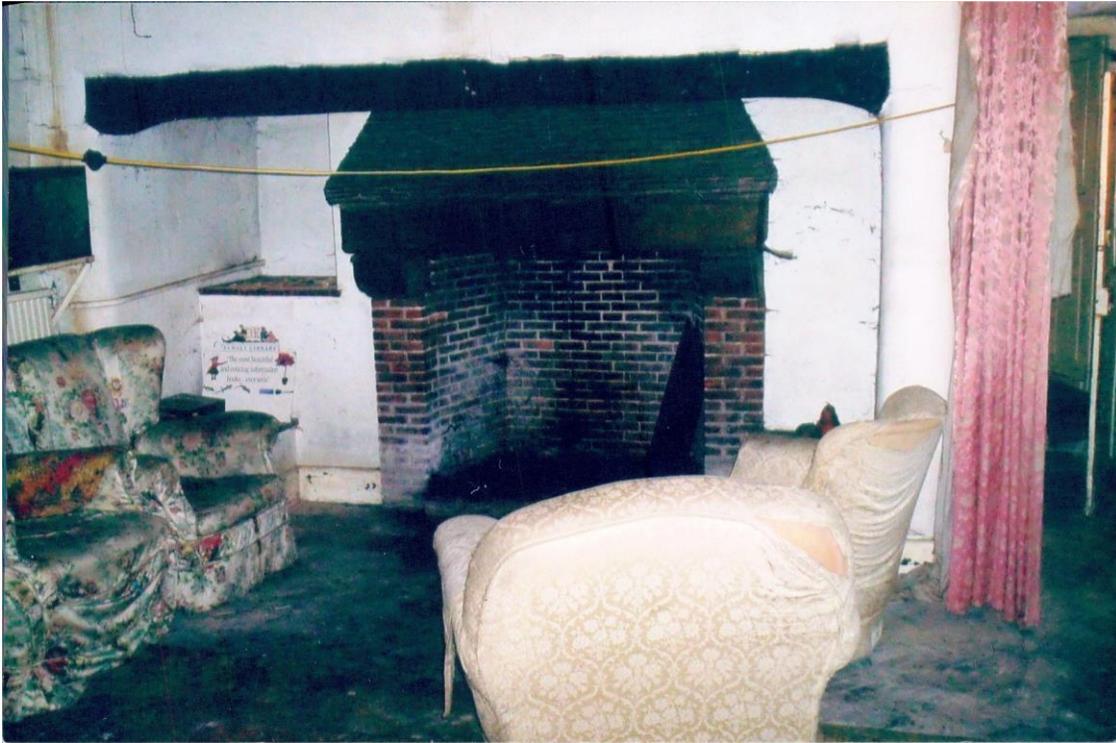
The breakfast-room fireplace before

Down in this breakfast room the asbestos floor tiling was removed and work started on the inglenook fireplace. This was of a design that could best be described as an acquired taste with a large tile hood from the 1920s or 1930s that had allegedly been installed as part of an Arts and Crafts revival makeover. During the process of removing this and knocking out a concrete TV stand at one side of it the remains of a bread oven complete with stoke-hole were discovered at one end whilst at the other, opposite the door to the cellar an unexplained low level brick arch was revealed - possibly for clearing out ash from another, larger oven?

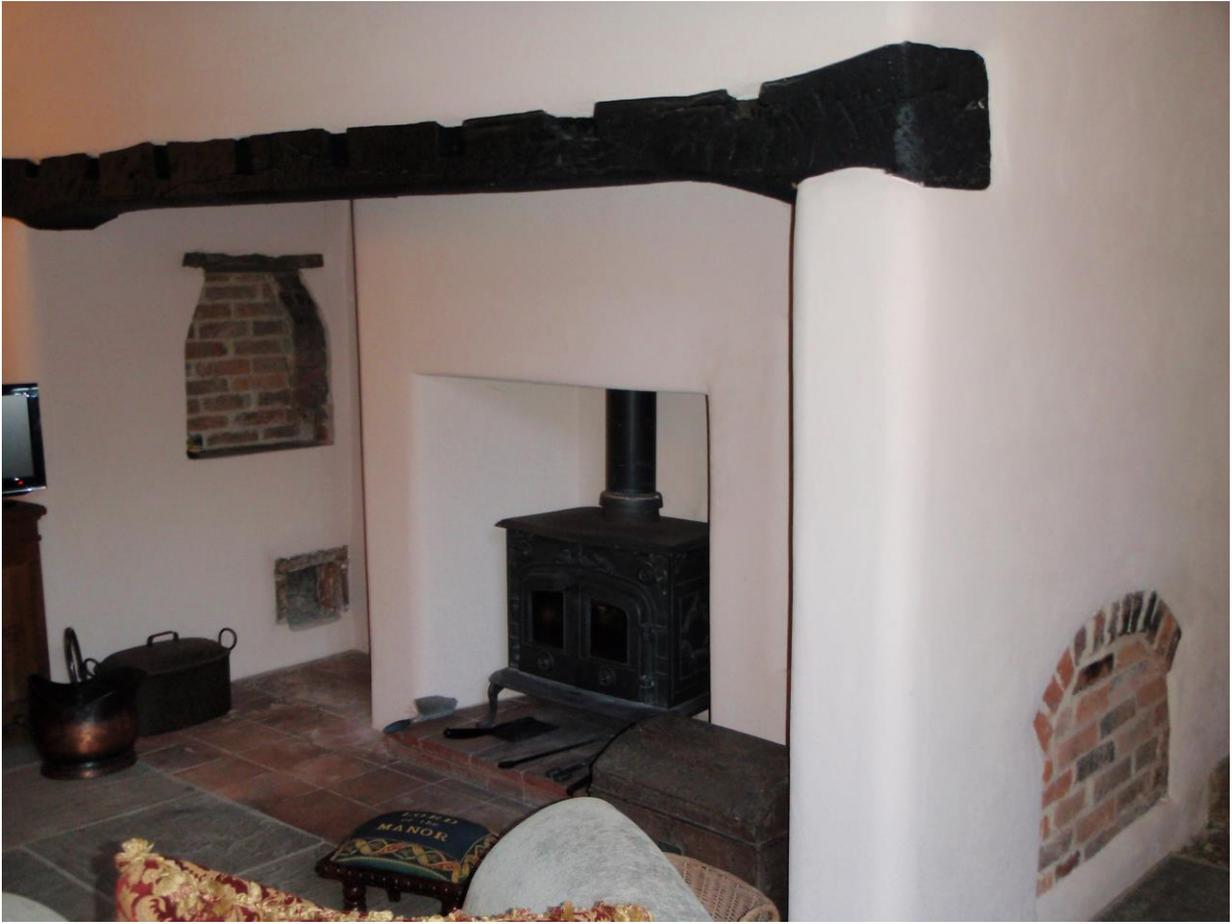
( and after)

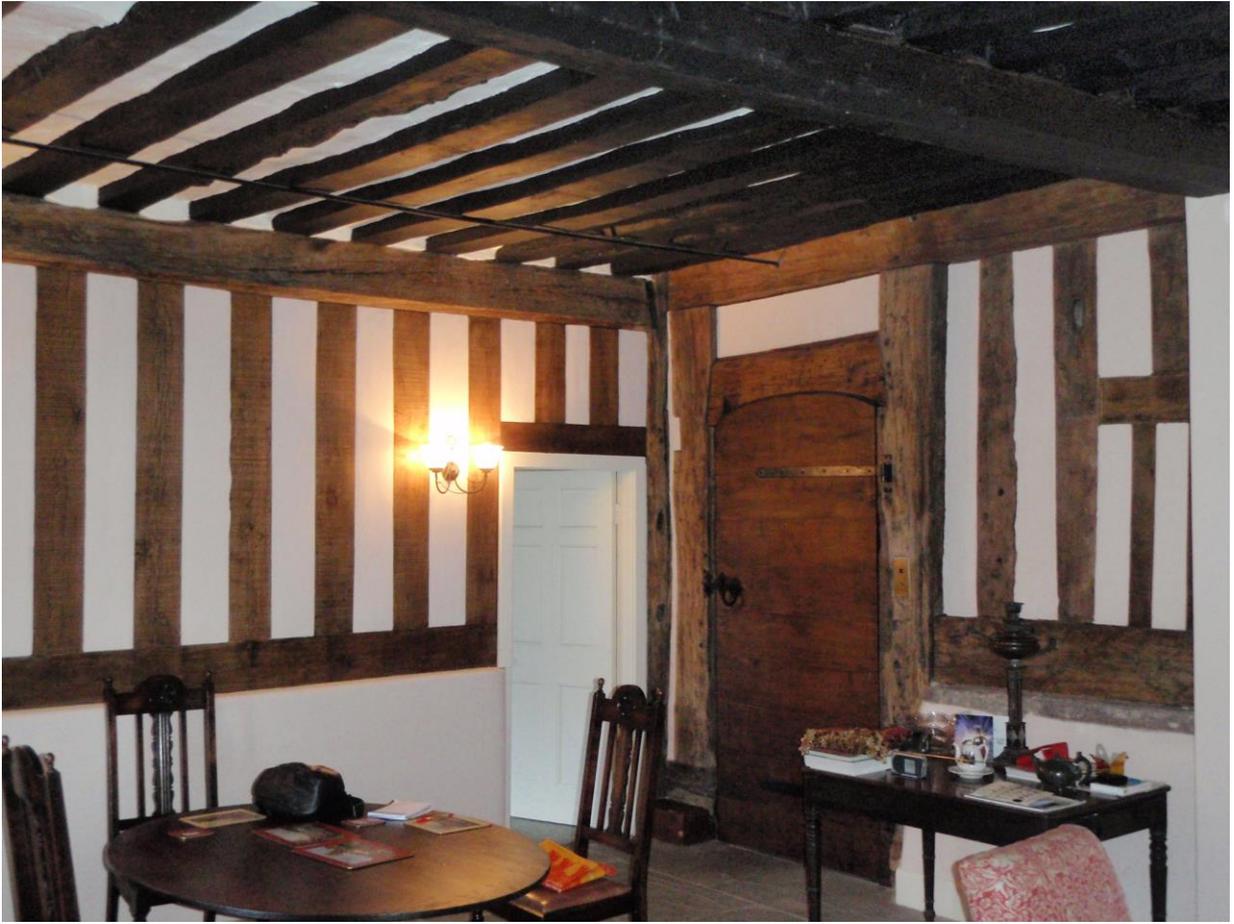
And at the same time, as we continued to remove old plaster and modern paint from the walls the frame to the original 1497 was discovered, surrounding a later door into the room and with a small original window to its right.

Breakfast Room showing, (on the right), the 1497 door-frame, studding and window, and, (on the left), 21<sup>st</sup> century replacement studding

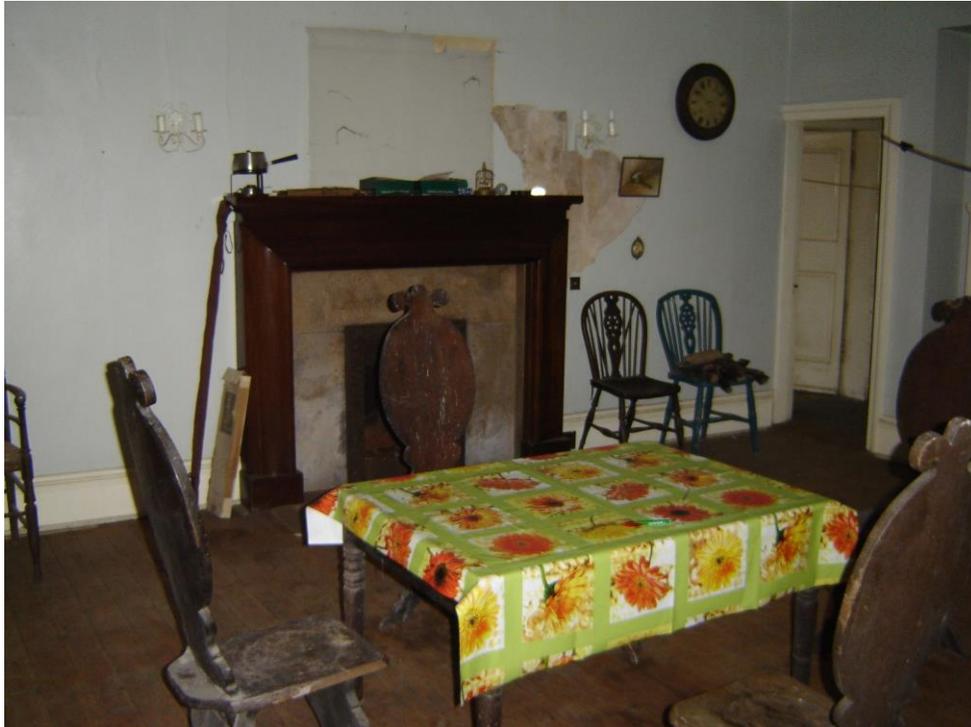
In the dining-room, (which was decorated in a pseudo-Georgian style), an investigation of the north wall revealed a large Tudor fireplace in situ behind a still decently sized but rather smaller Edwardian replacement.

Dining Room fireplace, (before)

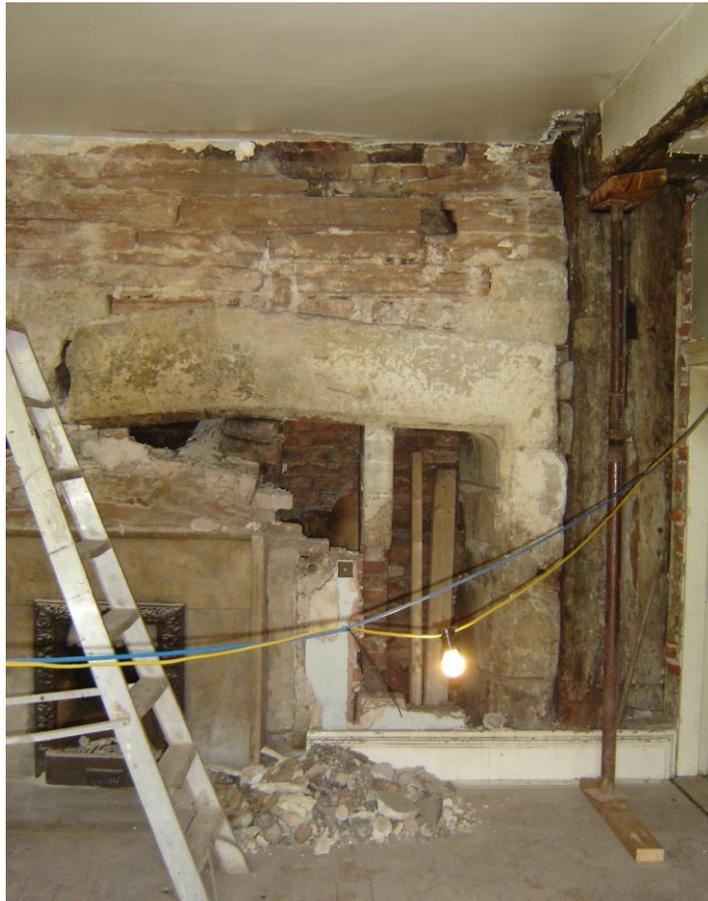
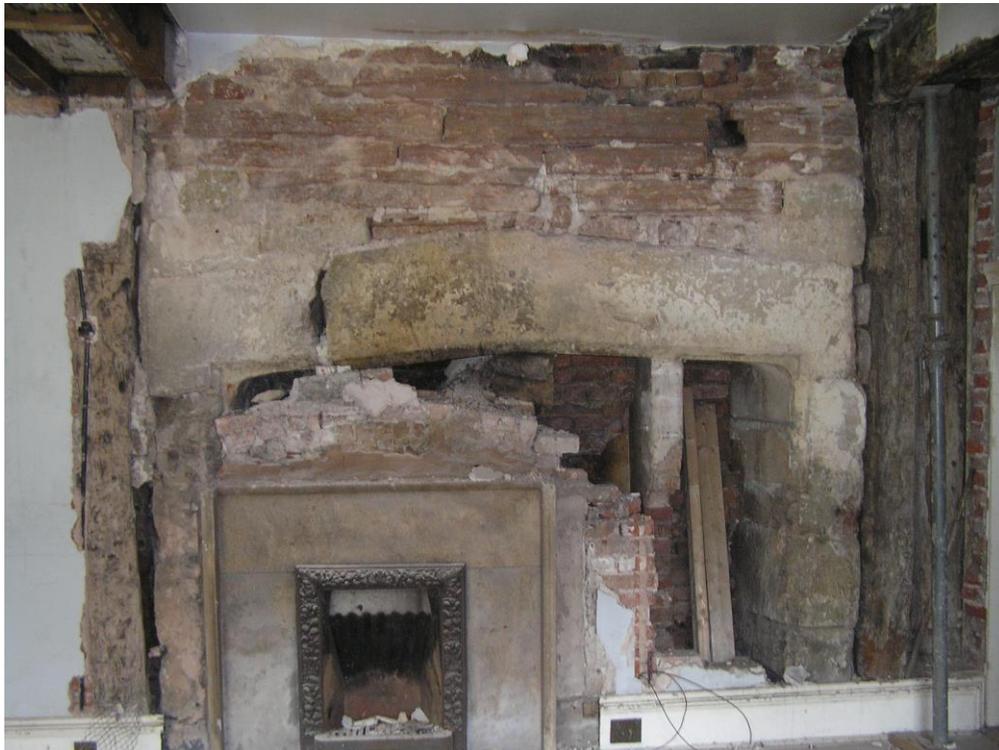
During

However, in common with most of the rest of the house, this was in dire need of repair. The lintel, weighing around a ton, had at some point broken in two about two thirds of the way along, its collapse, (which would have brought down the wall and the chimney above), having been prevented by the insertion of two brick piers. The repair required the propping of the wall above the fire-place, the jacking up of one side of the lintel and the insertion of epoxy bonded steel pins to hold the two parts together, (but just to be on the safe side), we also left the two brick piers in place as well.

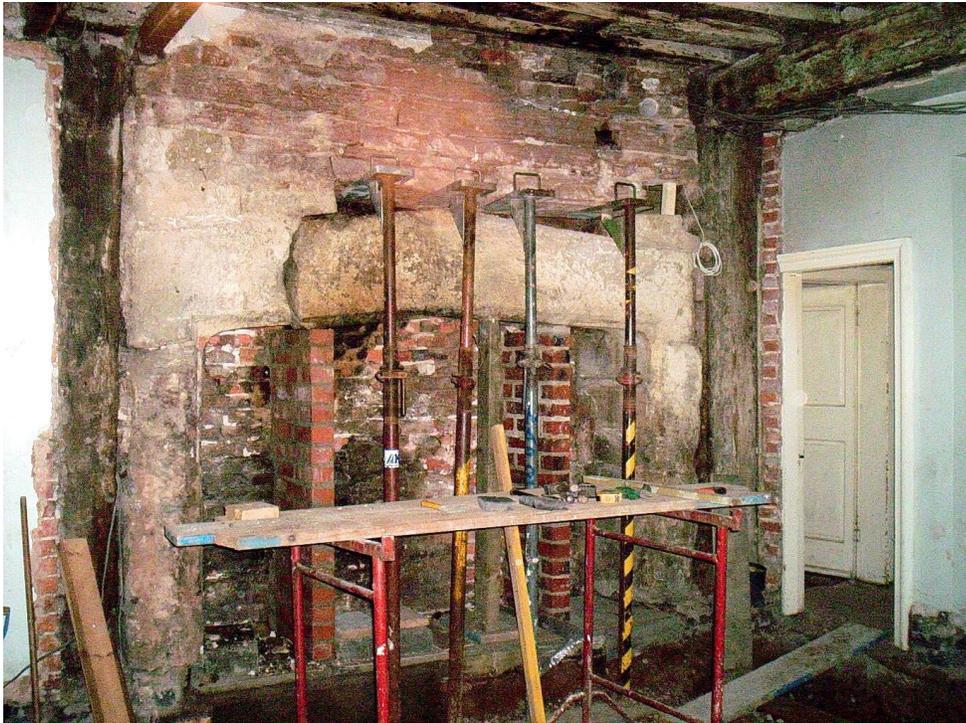
Needle and propping to support the wall over the fireplace, (the break in the lintel can be seen just to the left of the left hand brick pier).

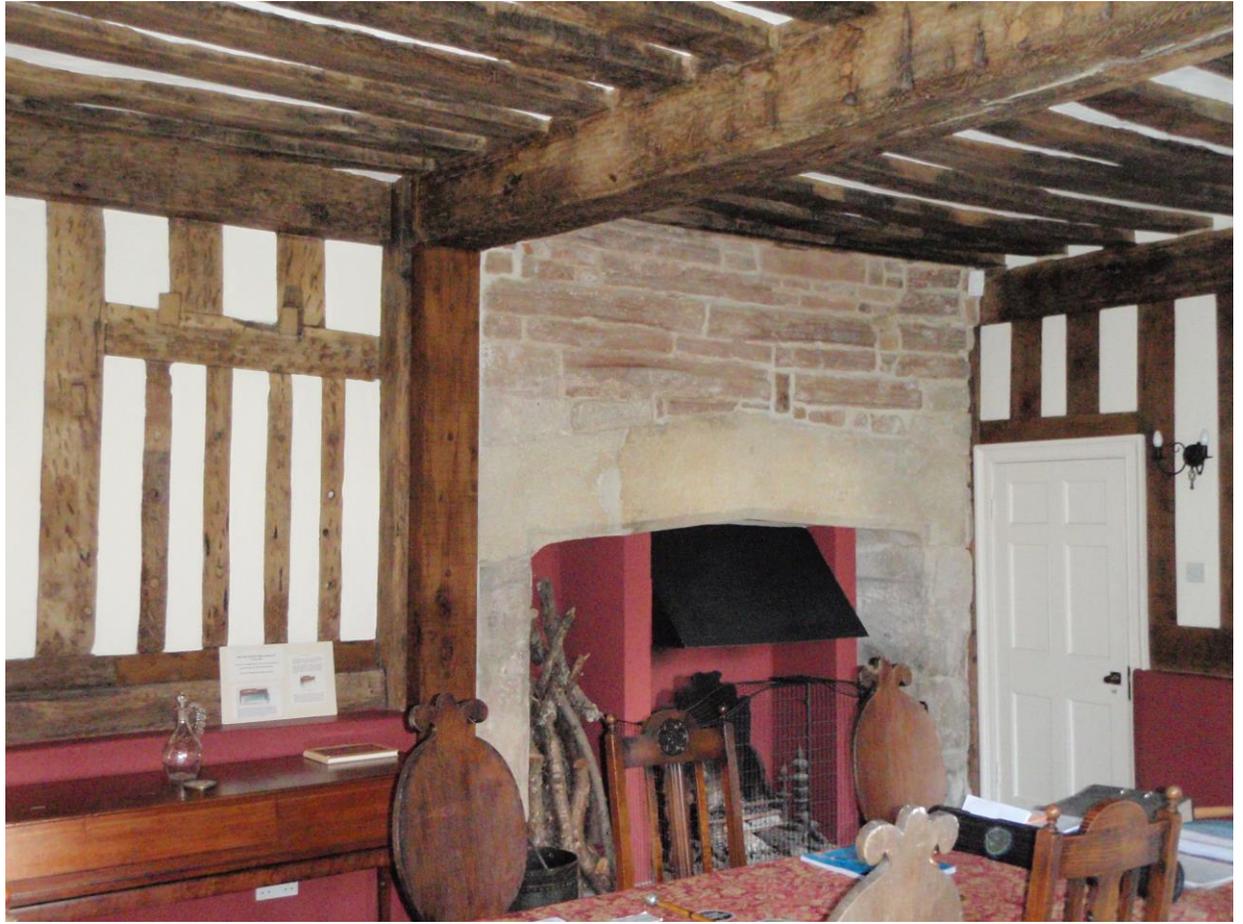
And after

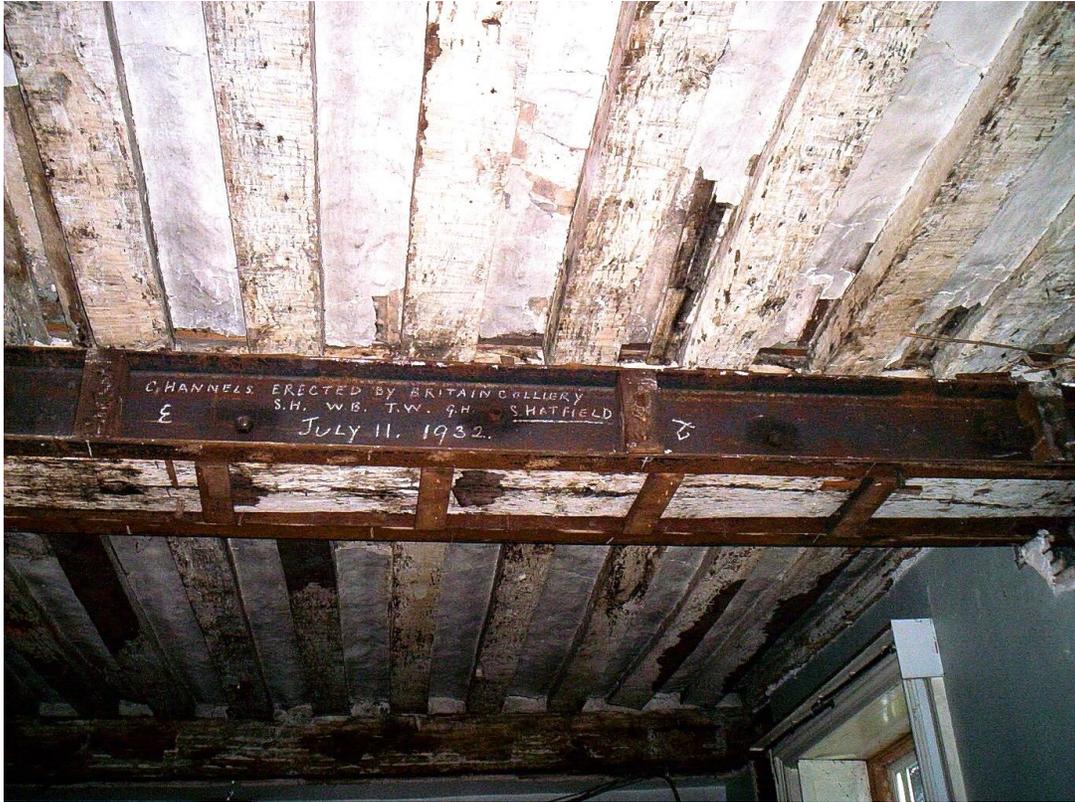
The work on the fire-place also required the taking down of part of the plaster ceiling which in its turn exposed the main tie beam with two rather (un)attractive steel channels bolted to it, with the date they were erected, (July 11<sup>th</sup> 1932), helpfully chalked on them. Having fortunately taken the precaution of propping the central beam before removing these two channels it soon became apparent why they had been inserted. Not only had the building “spread” by about 4” and hence the tie beam had lost most of its bearing at both ends and appearing to be in some danger of dropping completely out of the post at its north end, the beam itself had cracked across the middle as well.

The first of these problems was rectified by the insertion of a new oak post in front of the original one at the point of danger, and the second by taking up part of the plaster floor in the main bedroom above where the beam had failed, cutting a slot cut in the beam from above and inserting a steel plate held in place with no less than twenty-seven 1" diameter bolts, (see below).

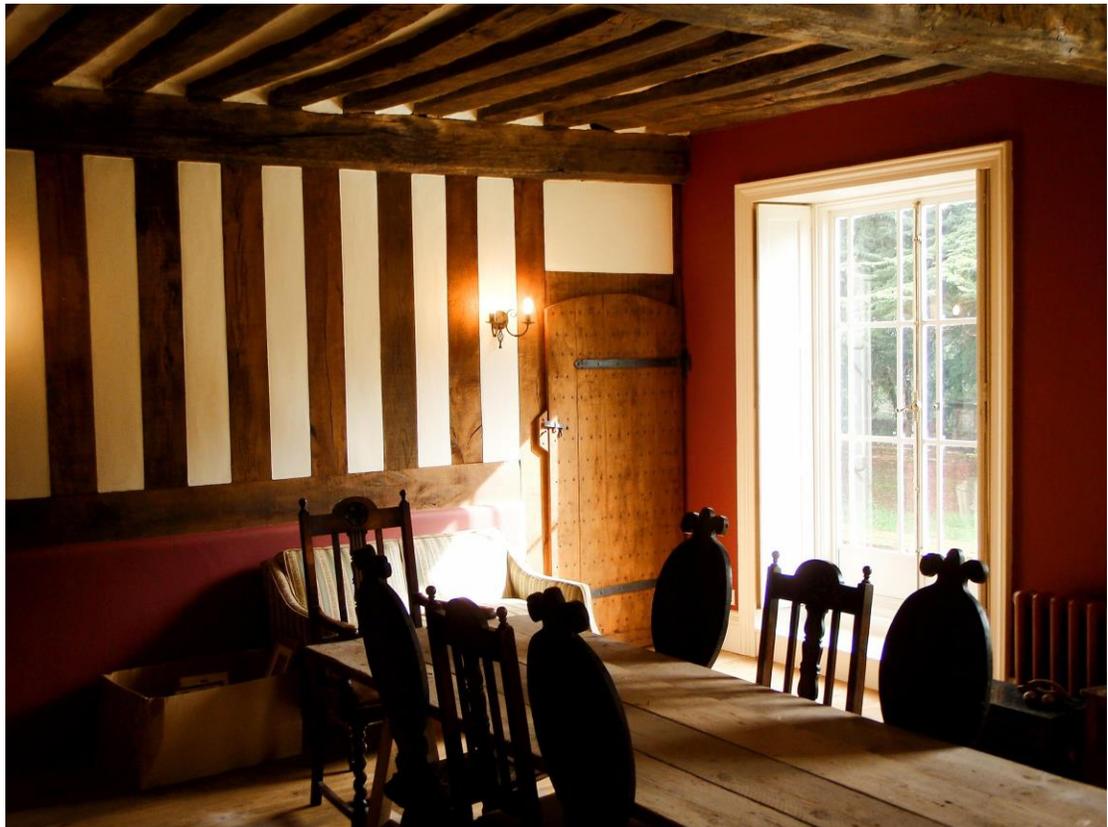
In the process of all this another timber framed window was revealed to the left hand side of the fire-place and the underside of the cross beams at each end of the room became visible, each of which showed a series of mortises or slots for the stud walls that had once divided the rooms. As it was now apparent that the room retained a wealth of original features it was decided to return it to as near its early 16<sup>th</sup> century appearance as possible by inserting new studs in the positions indicated by the slots – the only point of debate was that it was not possible to determine if these studs would have extended all the way to the floor or finished at the same level as the outer wall studding, (the option we chose to install). The lack of mortises at the south end of each of the tie beams was taken to indicate the location of former doors and these were also replaced, even though this meant that one of the “new” doorways now opens onto a blank wall, since to make it a functioning door would have required cutting out part of the 19<sup>th</sup> century panelling in the drawing room.

Dining Room showing new wall and door between it and the breakfast room, studs positioned to fit original mortises in top beam.

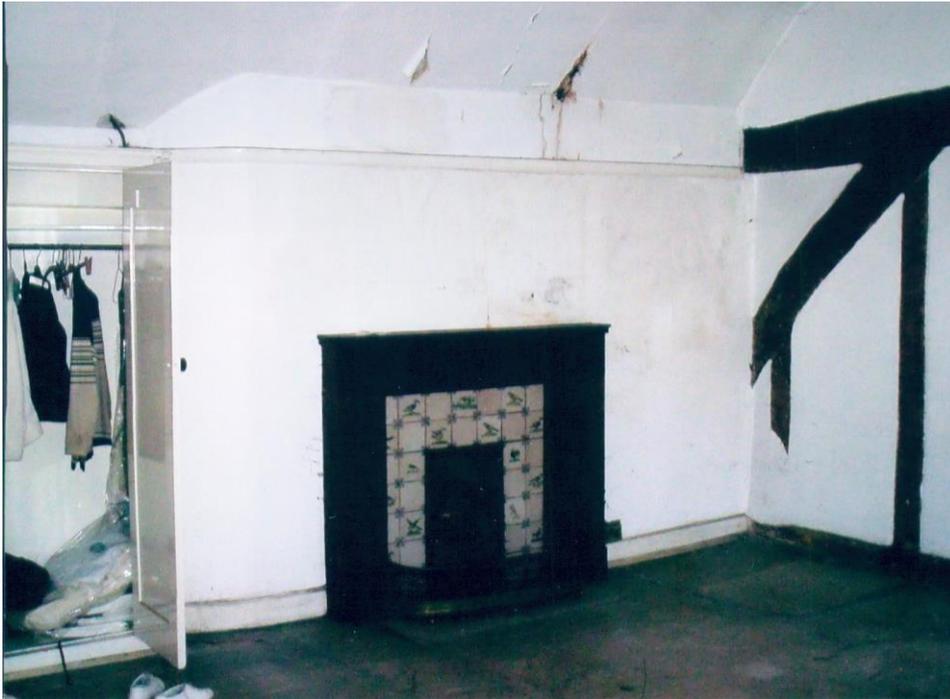
Meanwhile, in the main bedroom upstairs, (directly above the dining room), removal of plaster on the north wall revealed another Tudor fireplace

The Main Bedroom Fireplace, (before)

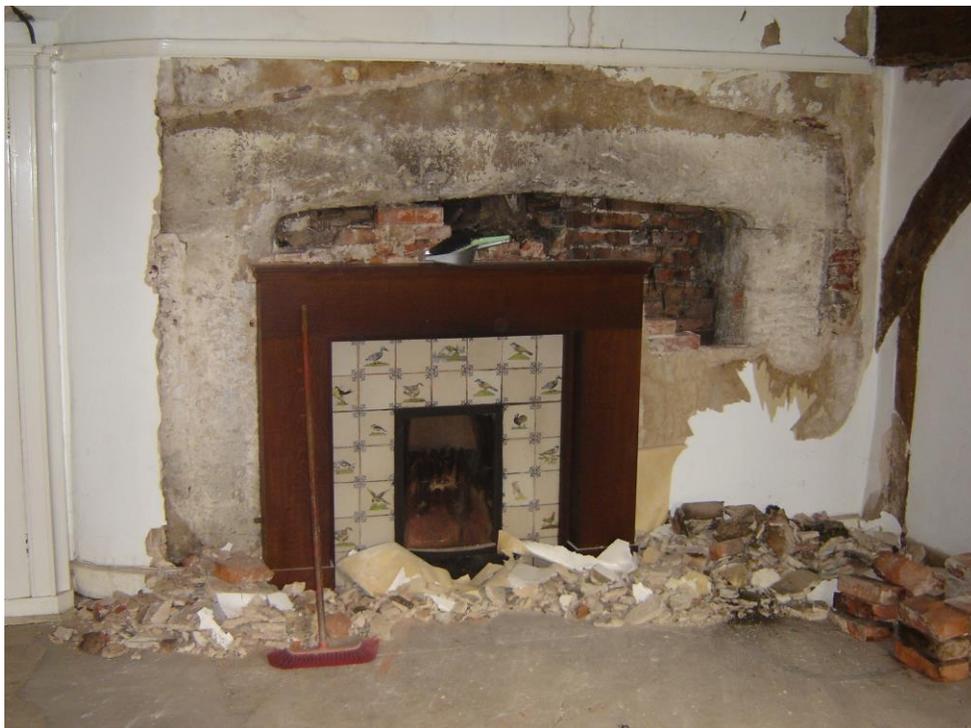
The Main Bedroom Fireplace, (during)

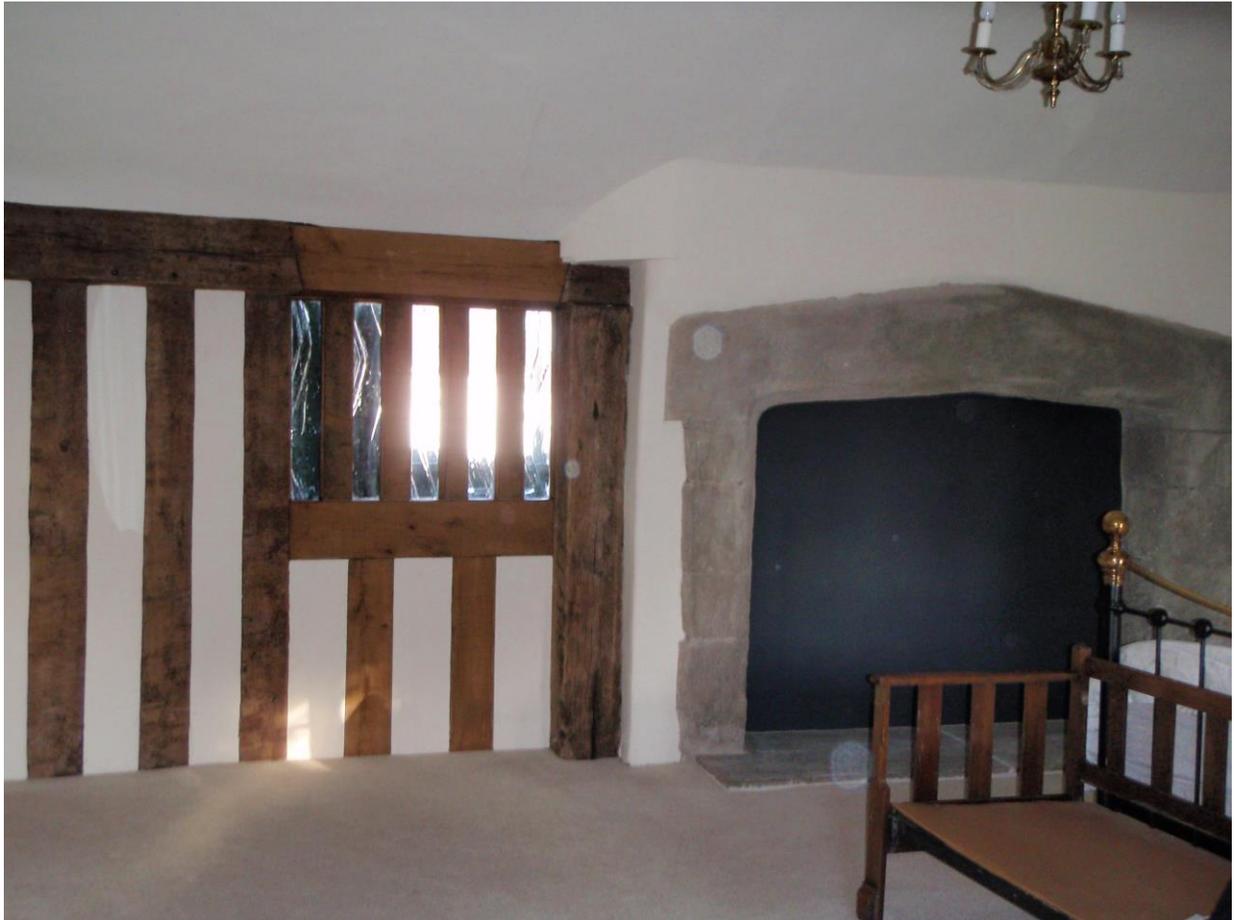
And the removal of a 1930sa built-in wardrobe to the left of this fire-place in its turn revealed the location of another of the original windows, (since reinstated), mirroring the arrangement in the dining room below.

The Main Bedroom Fireplace, (after), with window to the left.

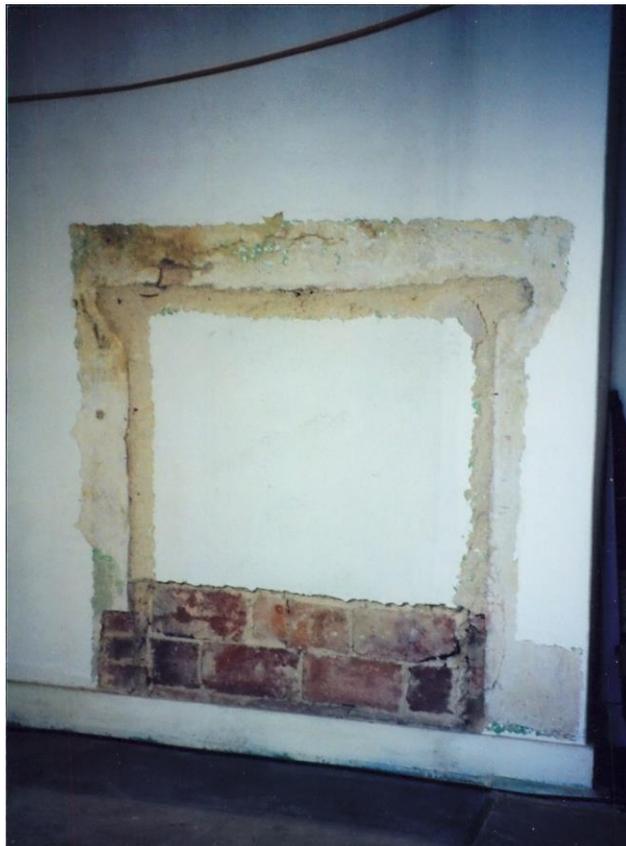
The ongoing repair works also revealed a further “ghost” fireplace on the upstairs landing, backing onto the fireplace in the main bedroom. This ghost fireplace probably served the “North Dressing-room referred to in a description from of 1851, (see appendix iii).

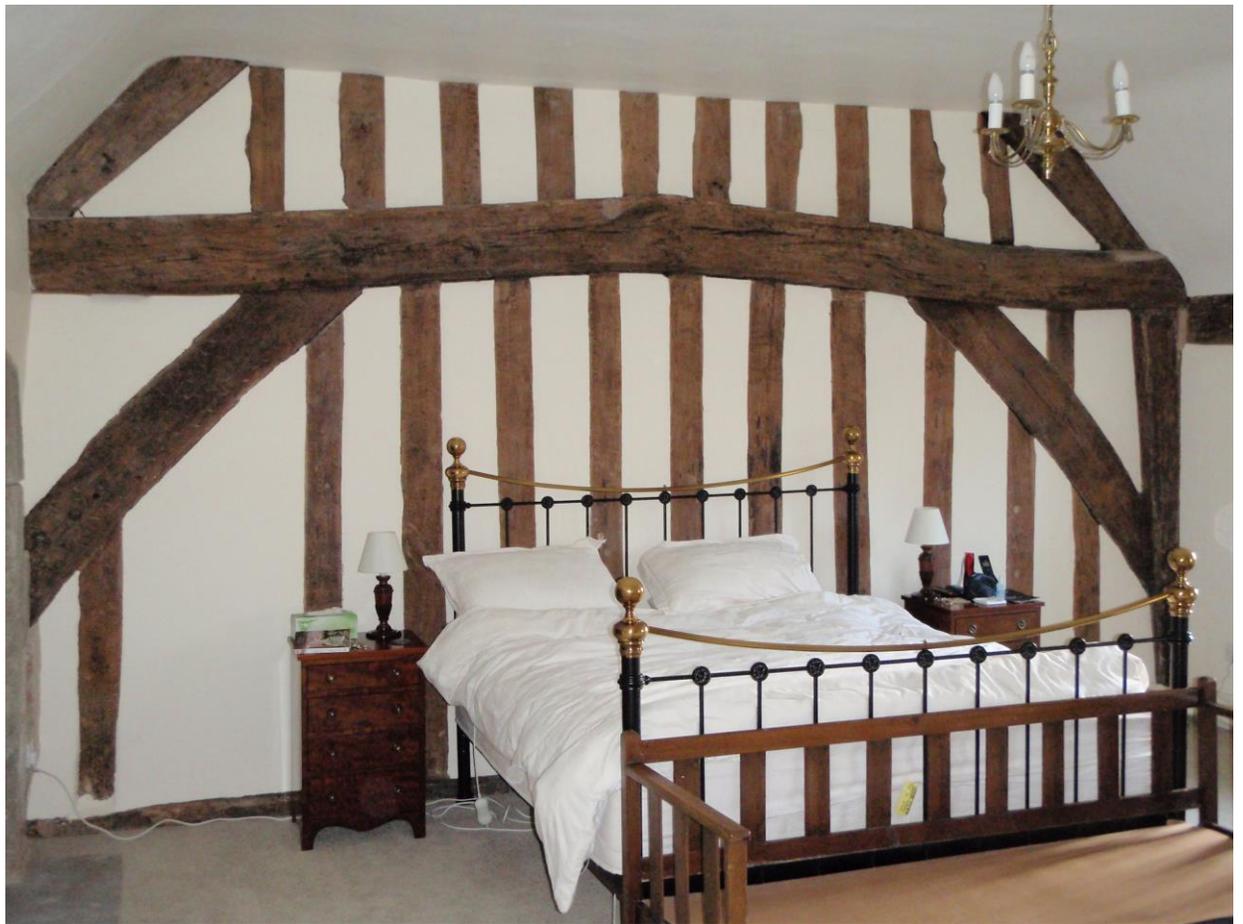
As work progressed more and more of the original timber frame and studding were revealed, as although all of the studding on the south face had at some point been replaced with brickwork, most of the original north wall had been preserved by being hidden inside the later rooms added along this face. In addition an early door-frame on the first floor, (which appears to have provided access into the original NW wing), two windows and the door-frame to the original cross-passage also survived.

Studding between bay 2 and bay 3 in the Main Bedroom

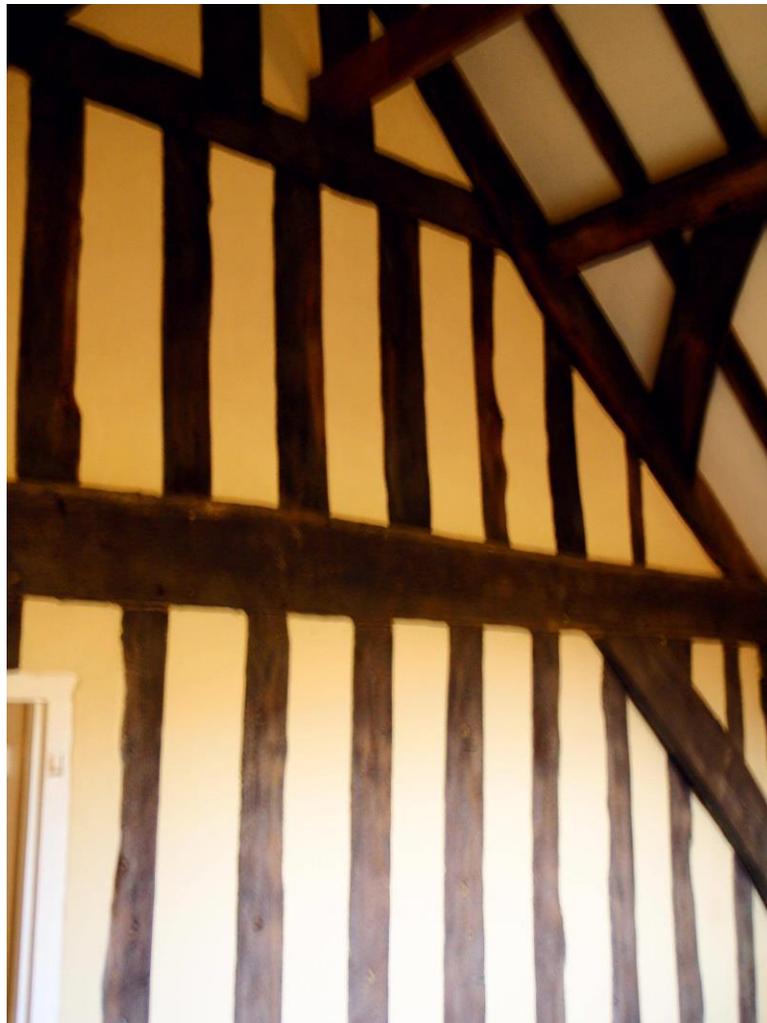
However, the room with the most extensive and visible original timber framing is undoubtedly the East Bedroom, erected in 1500. Before restoration work commenced, the only way to see the roof and the upper part of the wall framing in this area was by climbing through the roof space of the main part of the house; this involved negotiating an 18" gap in the 1497 gable, dropping down onto a plank in the smoke bay, crawling around the chimney and squeezing through a 9" gap between two studs and thence into the roof space over the bedroom. In order to reveal the 16<sup>th</sup> century roof and the studding in the frame between the fire-bay and this room without any of the aggravation noted above, it was decided to remove the later ceiling in this room, the only downside being a much lower amount of roof insulation here than in any of the other upstairs rooms.

Timber Framing in the 1500 East Bedroom

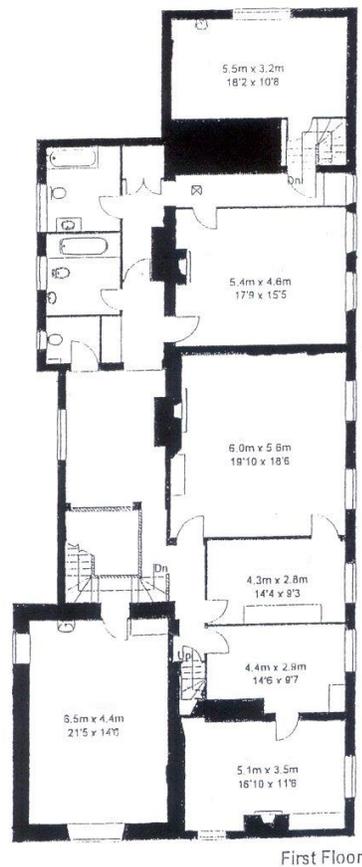
First Floor plan before alterations, (no structural alterations on this level).
