# HEMPSHILL HALL

## Nuthall

This is a short account of the history and restoration of Hempshill Hall, significant parts of which were built in 1497, only twelve years after Richard III was killed at the Battle of Bosworth Field.

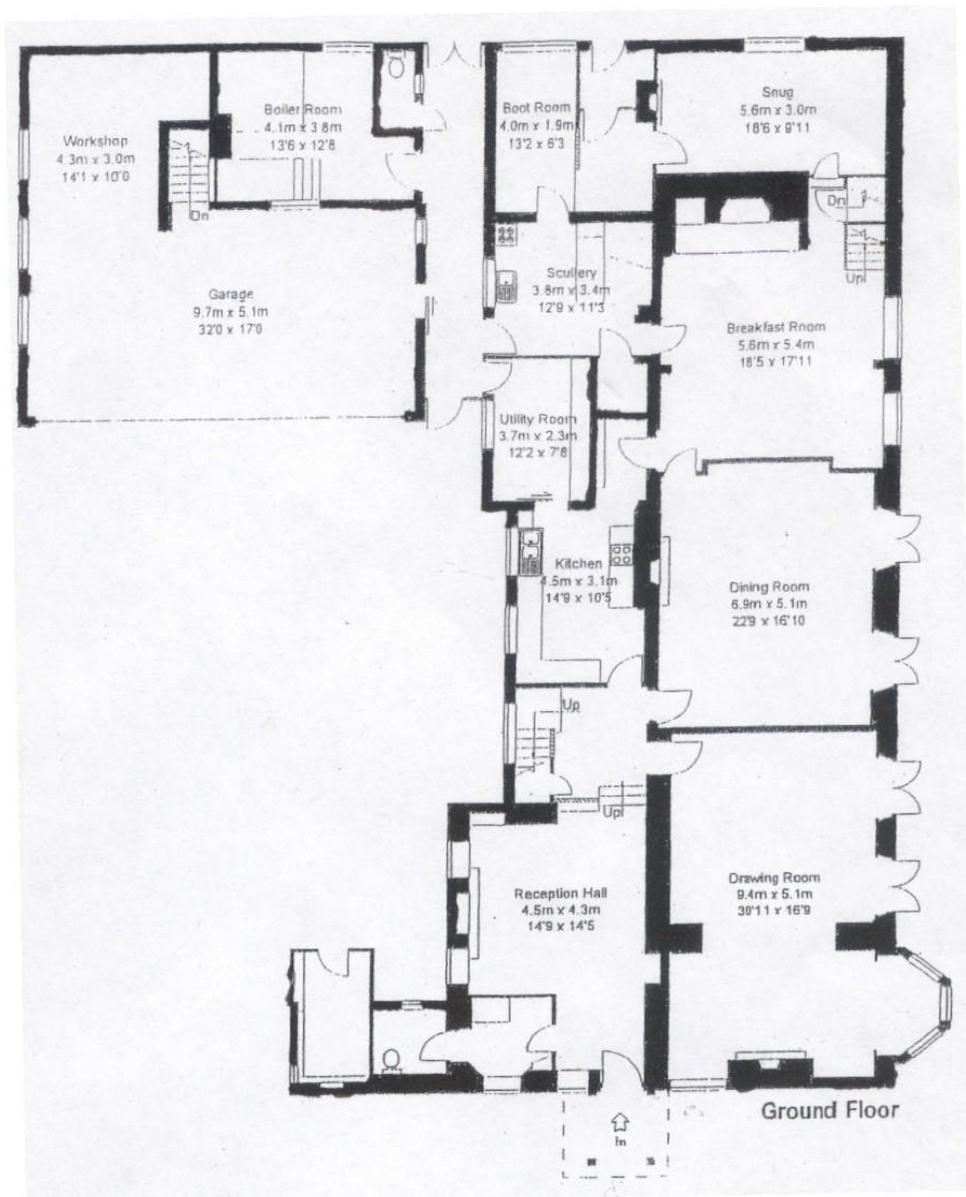
Ground Floor plan before alterations

The main alterations made to the ground floor were as noted below;

Garage, workshop and boiler room replaced with new garage, (back and part side walls of original retained)

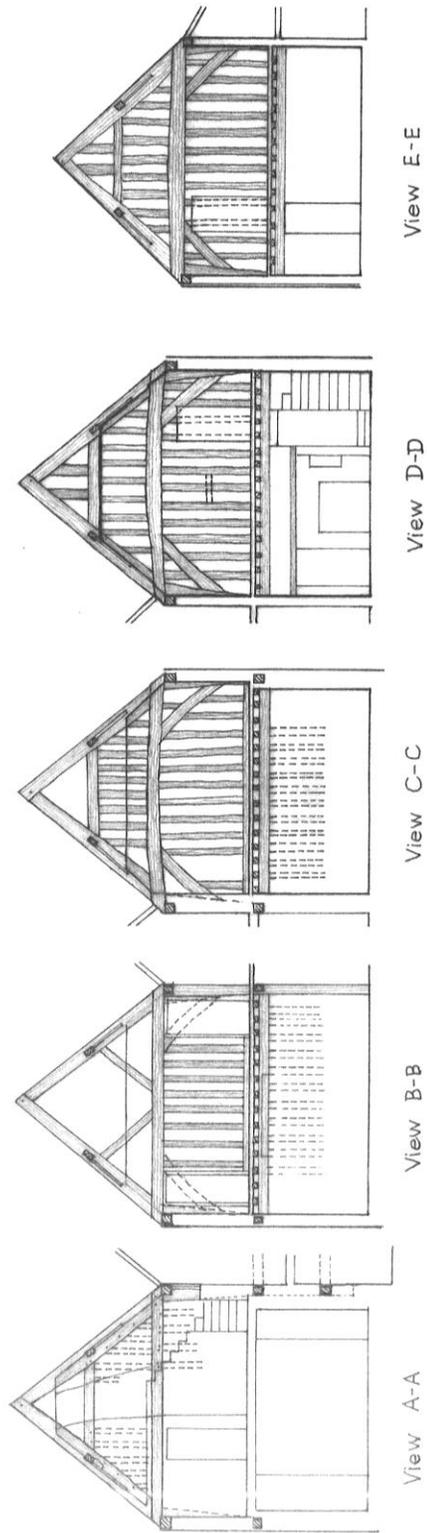
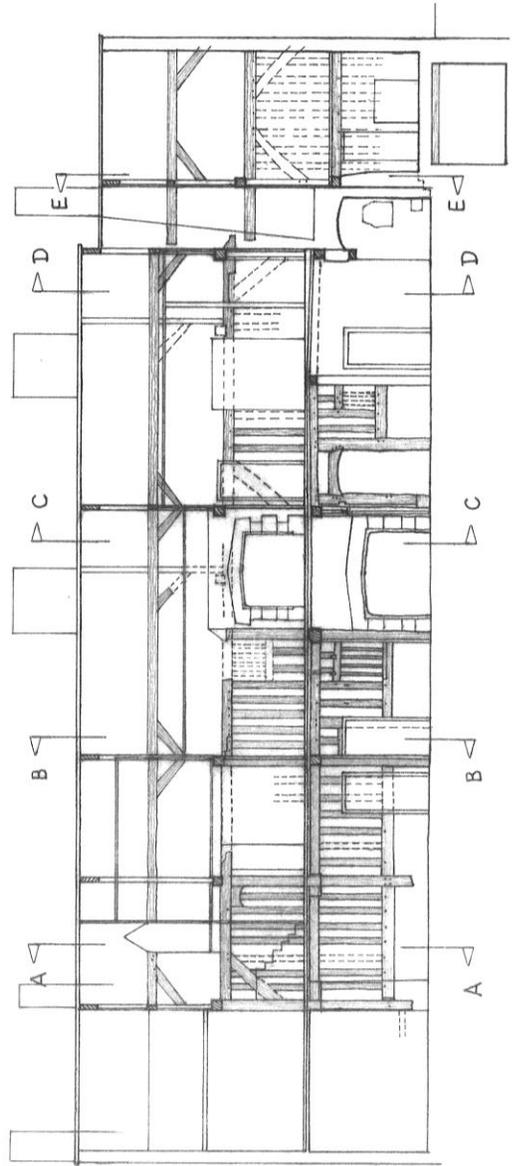
Roof and wall plates– almost complete  
Truss 5 + main posts  
Studding – from first floor to roof between smoke bay and 1500 bay

Sections (long section internal view of original north wall)  
Graham Beaumont 2013
